FLIGHT TESTS OF VARIOUS TAIL MODIFICATIONS

ON THE BREWSTER XSBA-1 AIRPLANE

I - MEASUREMENTS OF FLYING QUALITIES

WITH ORIGINAL TAIL SURFACES

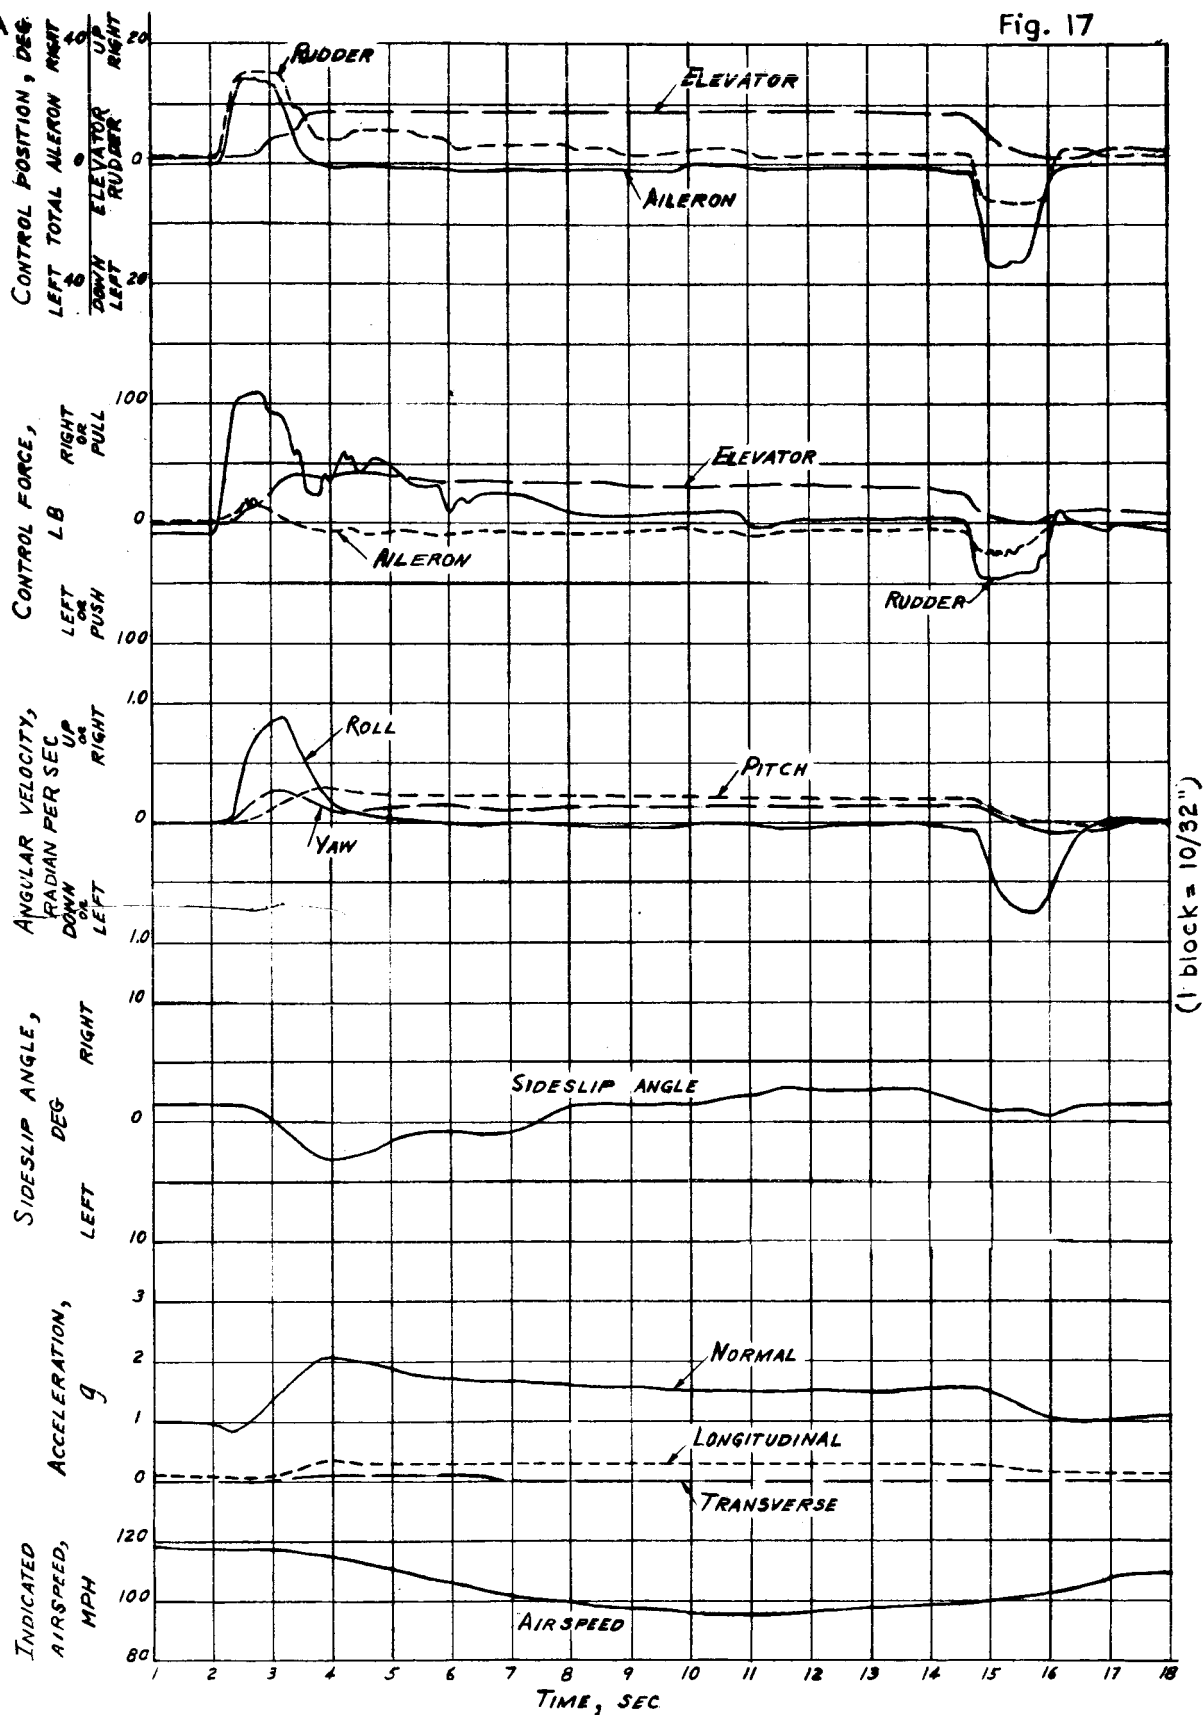
Fig. 17

Figure 17. - Time history of a rapid 180° turn to the right started at 118 miles per hour. Brewster XSBA-1 airplane; flaps up, gear up, 18 inches Hg manifold pressure, 1800 rpm.

Characteristics of the elevator control in accelerated flight. - The characteristics of the elevator control in accelerated flight were determined from measurements taken in abrupt pull-ups and push-downs from level flight and in rapid 180° turns. The results of the pull-ups and push-downs are presented in figure 13. Time histories of representative turns are presented in figures 14 to 17. The results of the tests pertaining to the elevator control may be summarized as follows:

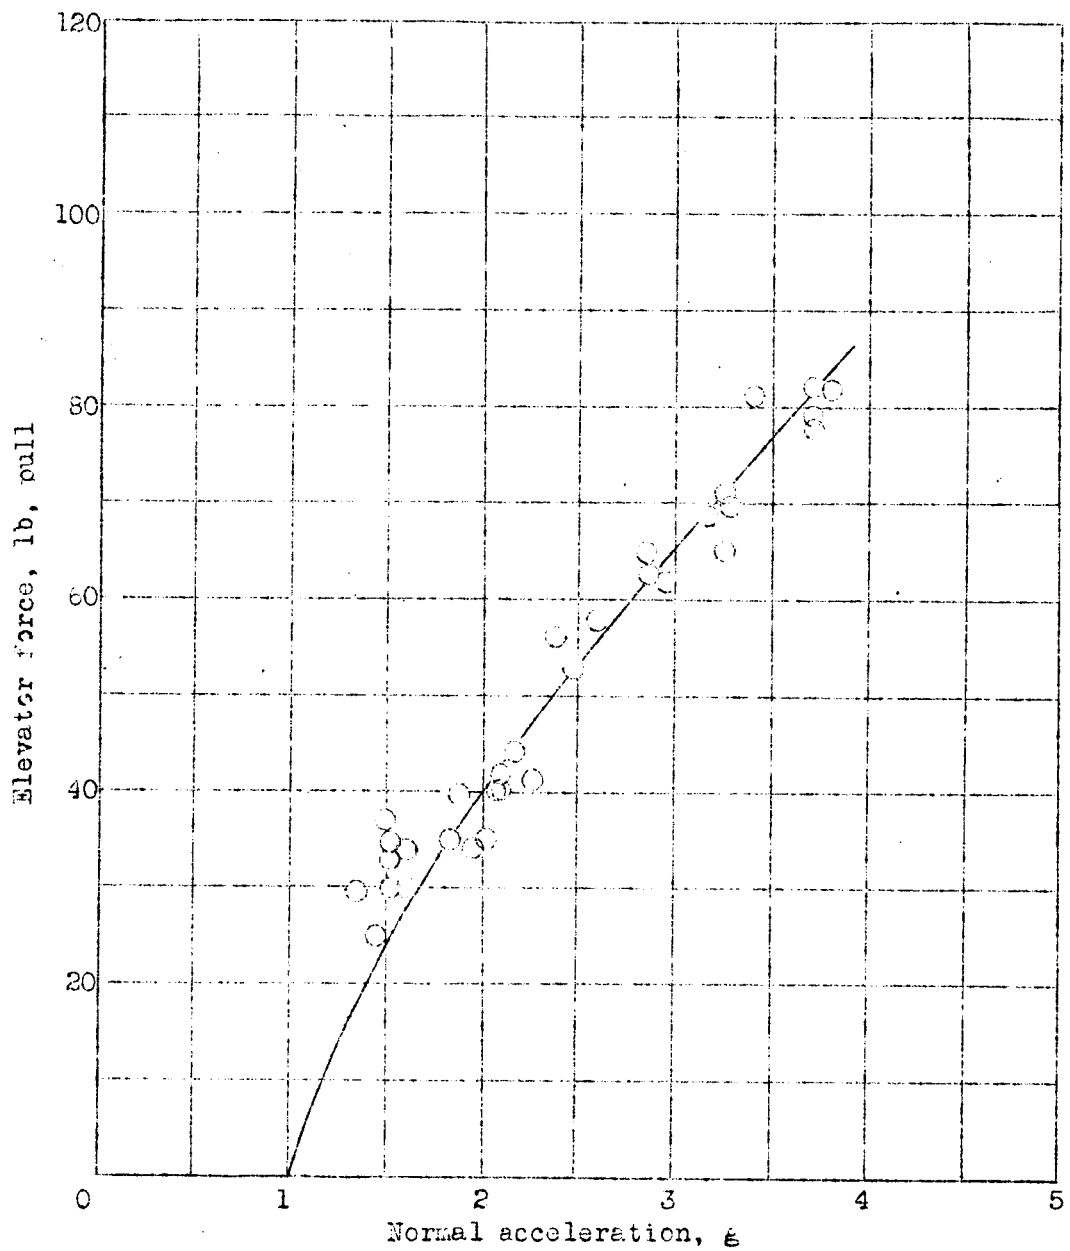
Figure 18.- Variation of elevator stick force with normal acceleration in 180° turns. Brewster XSEA-1 airplane; flaps up, gear up, 18 inches H_g manifold pressure, 1800 rpm.

(4) The variation of stick force with normal acceleration in 180° turns is plotted in figure 18. A large increase in stick force and elevator angle occurred as the stall was approached. For this reason, turns made at lift coefficients near the stall required a greater force per g acceleration than turns made at low lift coefficients.

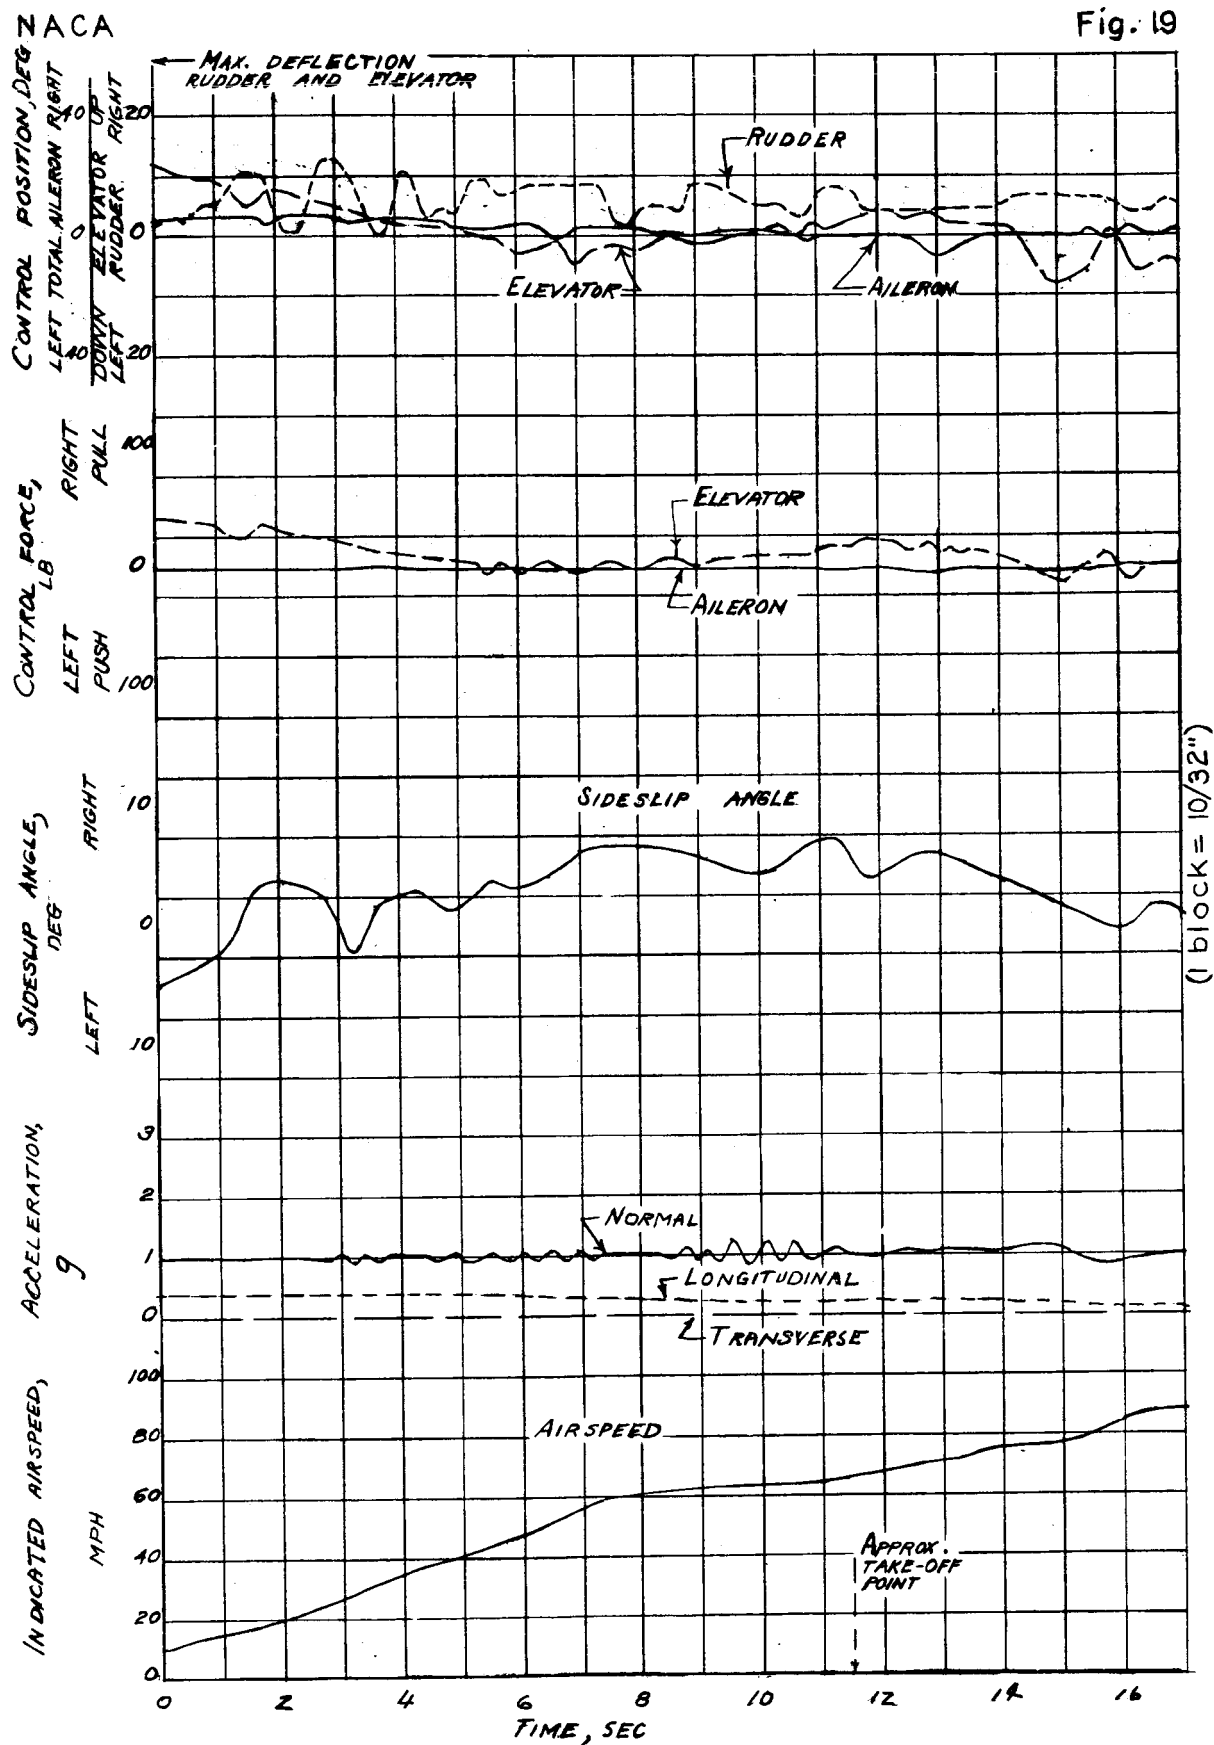
Fig. 19

Figure 19. - Time history of a take-off with flaps full down, 35 inches Hg manifold pressure, 2200 rpm. Brewster XSBA-1 airplane.

The elevator was adequate to raise the tail or to adjust the attitude angle as desired during take-off. Figure 19 shows a time history of a take-off in which the tail was raised fairly early in the run.

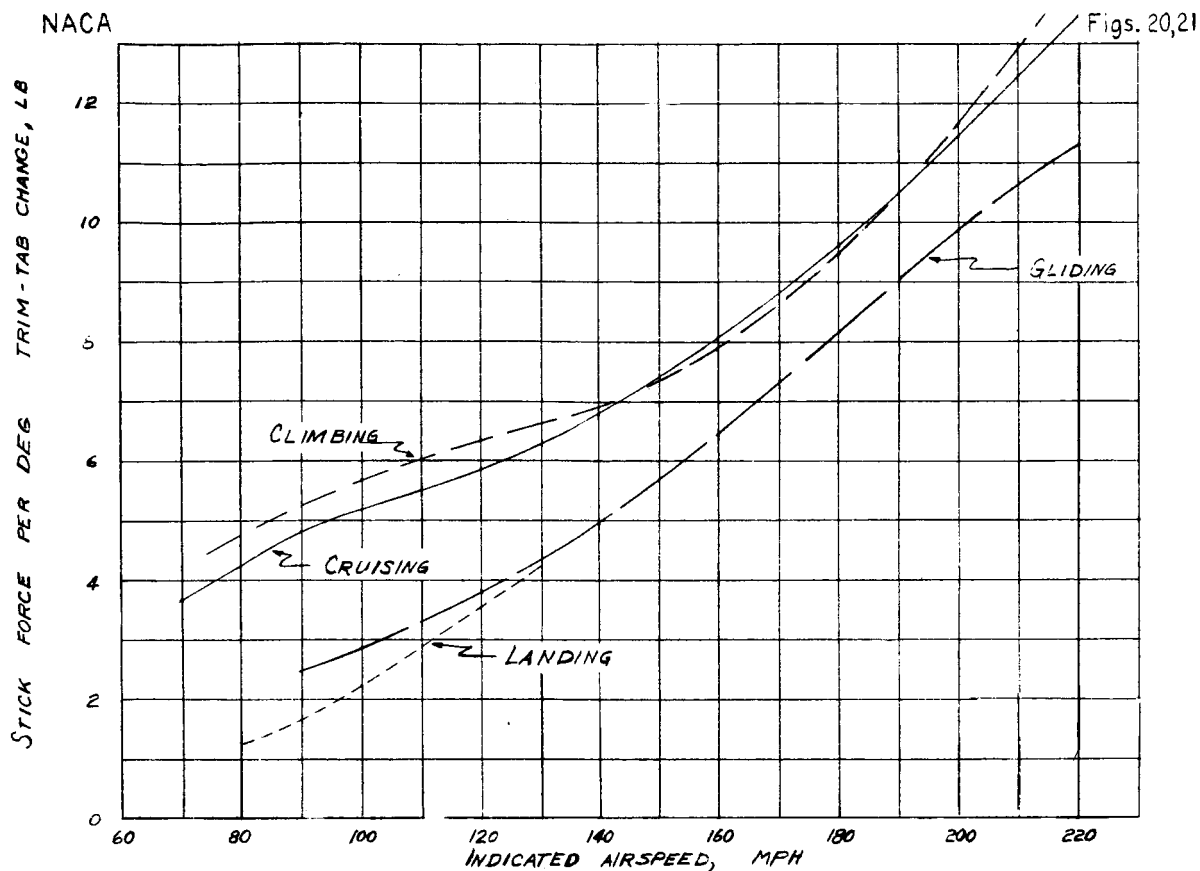
Figure 20. - Variation of stick force per degree trim-tab change with indicated airspeed, Brewster XSBA-1 airplane.

The stick force per degree trimming-tab change as a function of indicated airspeed in various flight conditions is shown in figure 20. The trimming-tab setting required to trim at zero stick force in these conditions is plotted in figures 9 to 11. The trimming tabs were sufficiently powerful to

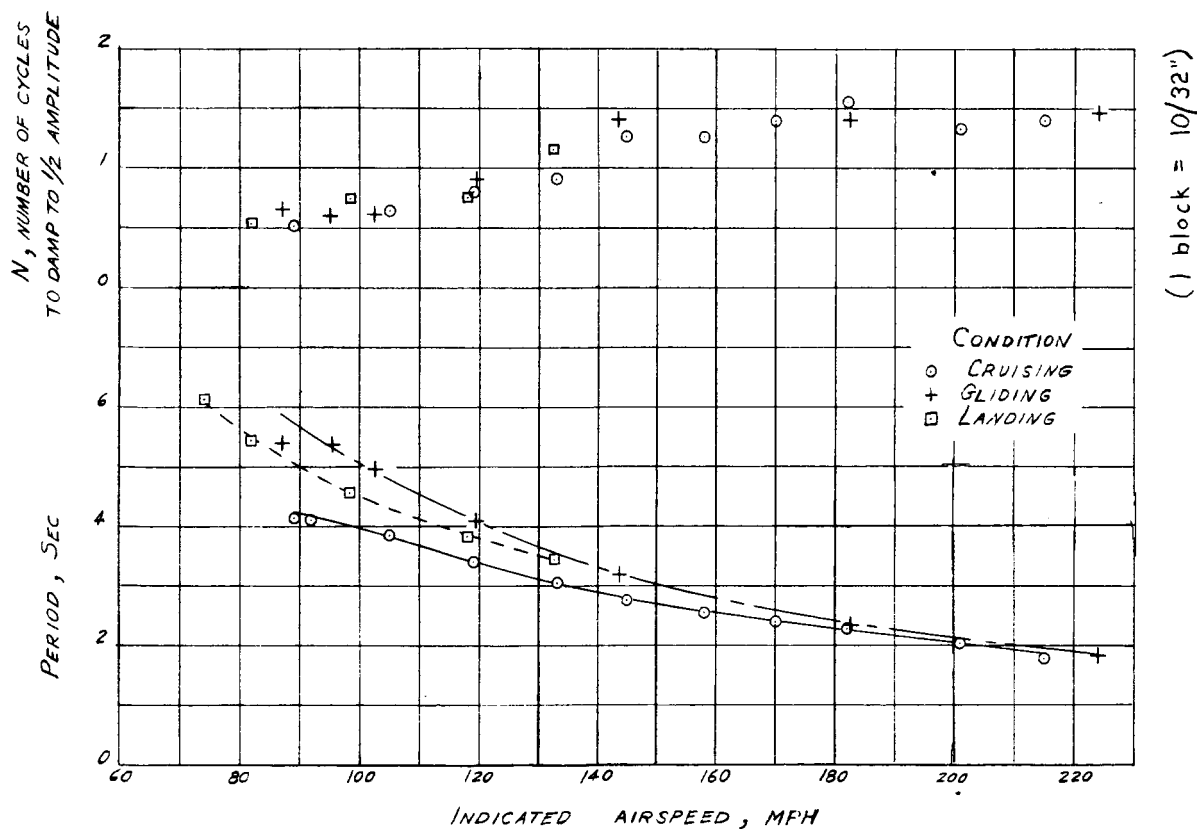
Figure 21. - Variation of period and damping of lateral oscillations with indicated airspeed. Brewster XSBA-1 airplane.

Characteristics of uncontrolled lateral and directional motion. - The lateral motion of the Brewster XSBA-1 airplane with controls free following a disturbance was measured in the cruising, gliding, and landing flight conditions at various speeds. The period and damping of these lateral oscillations as functions of airspeed are shown in figure 21. The conclusions reached with regard to the uncontrolled lateral and directional motion are as follows:

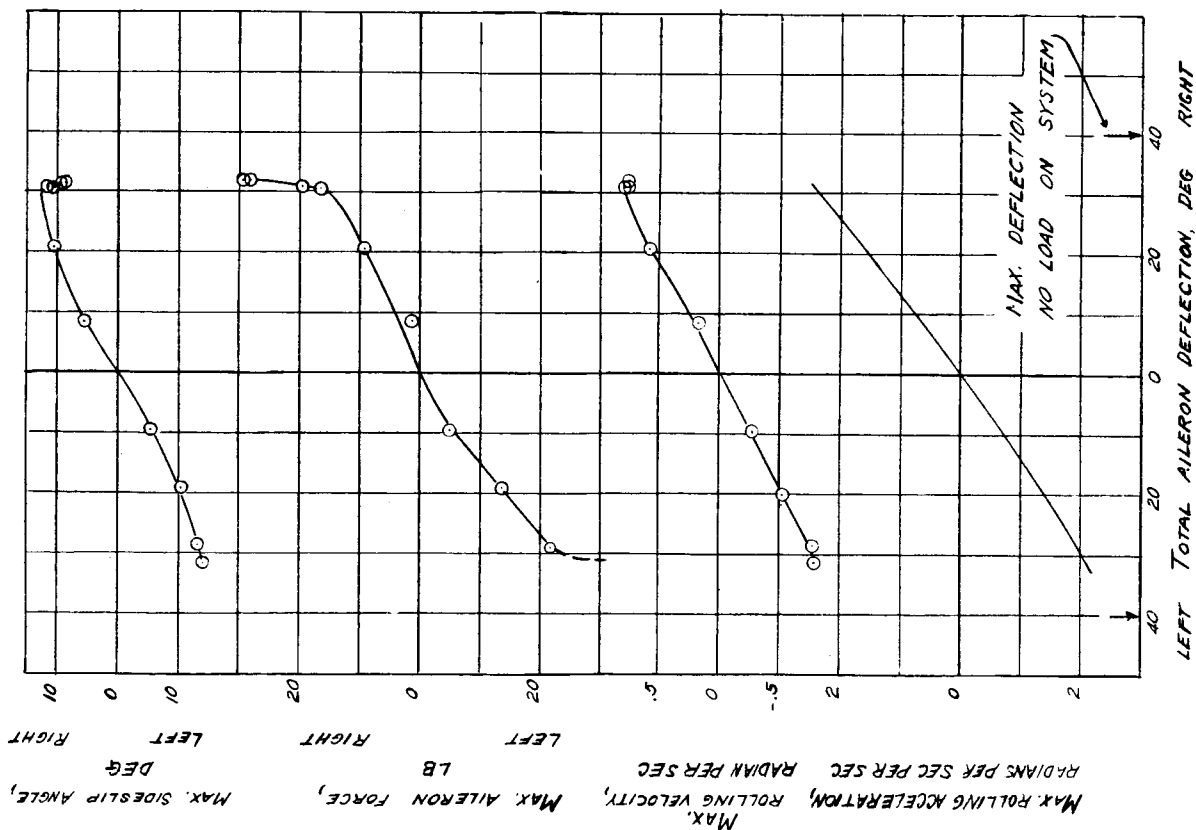
Figure 22. - Variation of maximum sideslip angle, aileron force, rolling velocity, and angular acceleration with aileron deflection in the cruising condition at 119 miles per hour, Brewster XSBA-1 airplane.

The results of the aileron tests are presented in figures 22 to 24. Figures 22 and 23 show the variation of the maximum values of sideslip angle, aileron force, rolling velocity, and rolling acceleration reached in aileron rolls with various aileron deflections in the cruising and landing conditions at low speeds. The quantities are plotted against total aileron deflection, which is the sum of the deflections of the right and left ailerons from their trim positions.

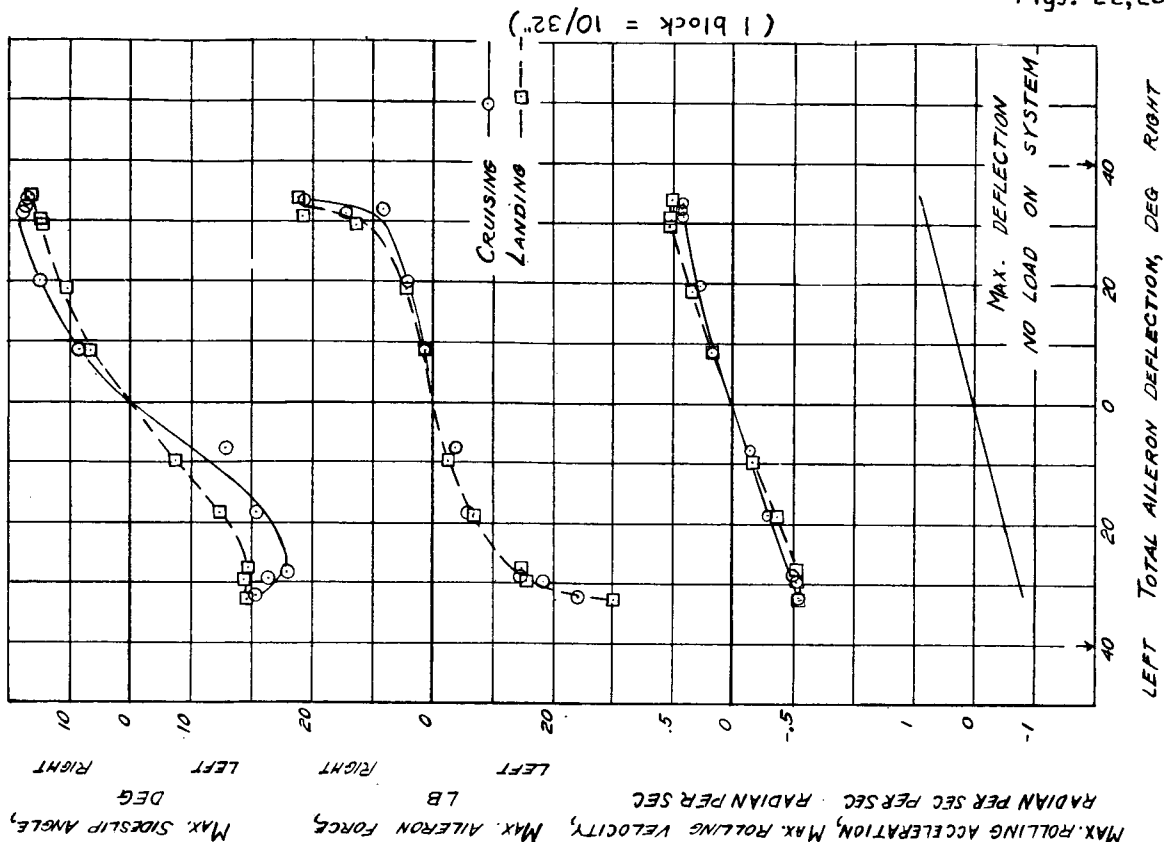
Figure 23. - Variation of maximum sideslip angle, aileron force, rolling velocity, and angular acceleration with aileron deflection in the landing condition at 85 miles per hour and in the cruising condition at 76 miles per hour. Brewster XSBA-1 airplane.

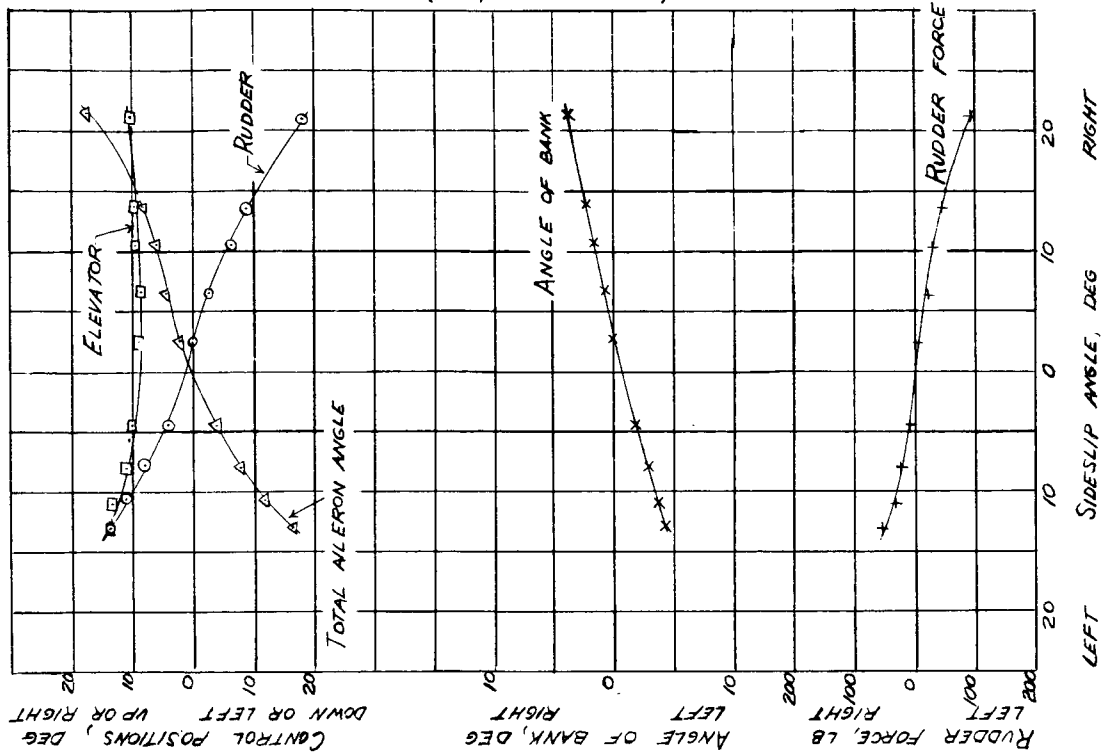
Figure 25. - Steady-sideslip characteristics in the gliding condition at 85 miles per hour (flaps up, gear up, power off). Brewster XSBA-1 airplane.

Rolling moment due to sideslip. - The rolling moment due to sideslip was measured by recording the aileron angles required in steady sideslips. These measurements were made at various speeds in the climbing, gliding, and landing conditions. The results are presented in figures 25 to 30, in which the rudder, elevator, and aileron angles, the angle of bank, and the rudder force are plotted as functions of the sideslip angle. The sideslip angle plotted is simply that recorded by the yaw vane. The recorded angles of sideslip may have differed as much as 3° or 4° from the actual sideslip angles. This error would be simply a shift of the zero setting. The slopes of the curves of the plotted quantities may therefore be considered correct. The conclusions reached are as follows:

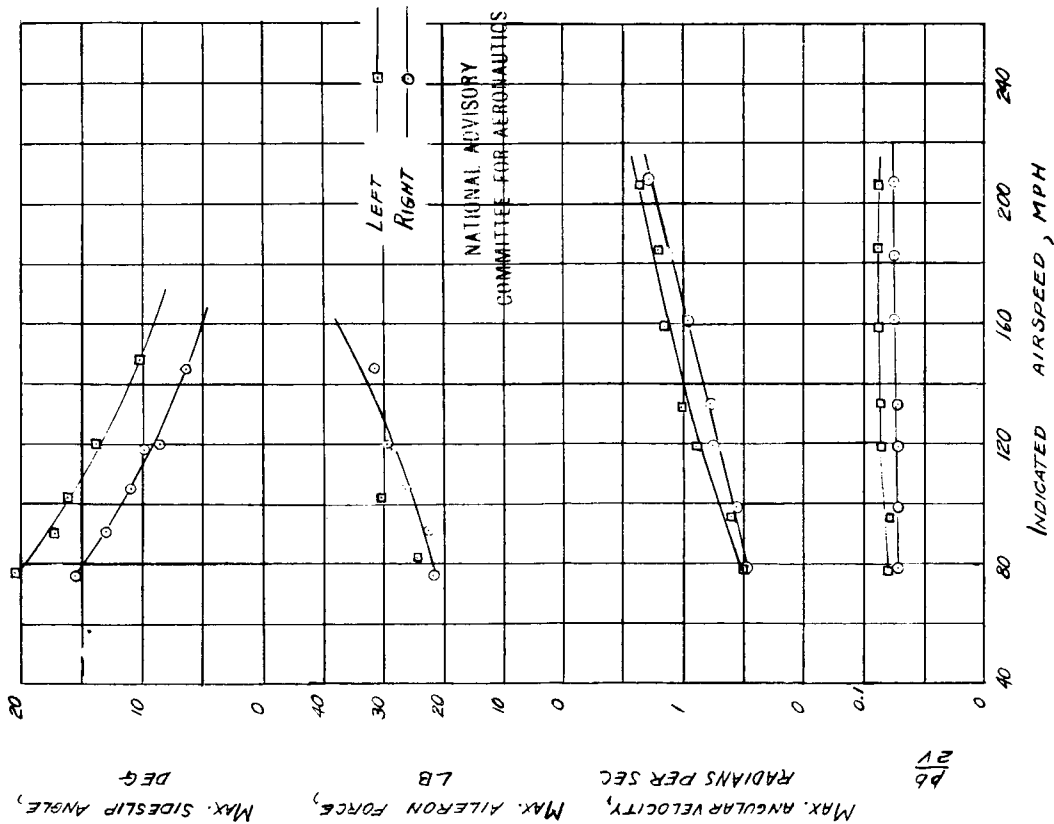
Figure 24. - Variation of maximum sideslip angle, maximum aileron force, maximum rolling velocity, and pb/2V with indicated airspeed in level flight for rolls with full aileron deflection (flaps up, gear up). Brewster XSBA-1 airplane.

The aileron forces for maximum deflection were considered excessive. From figure 24, it is seen that a force greater than 20 pounds was required to obtain full aileron deflection even at the minimum flying speed and that, at 175 miles per hour, which was about 80 percent of the maximum indicated speed, a force of about 42 pounds was required. This force exceeds the upper limit of 30 pounds at 80 percent of the maximum indicated speed given in reference 1.

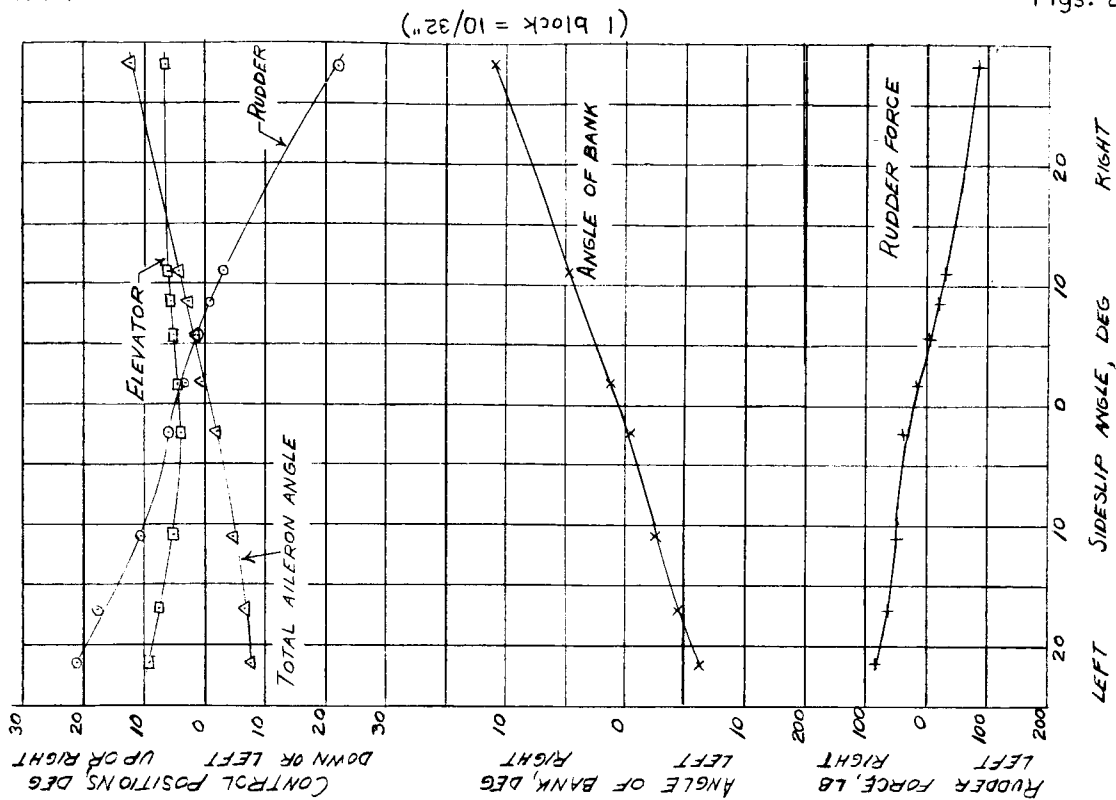
Figure 27. - Steady-sideslip characteristics in the cruising condition at 82 miles per hour (flaps up, gear up, cruising power). Brewster X3BA-1 airplane.

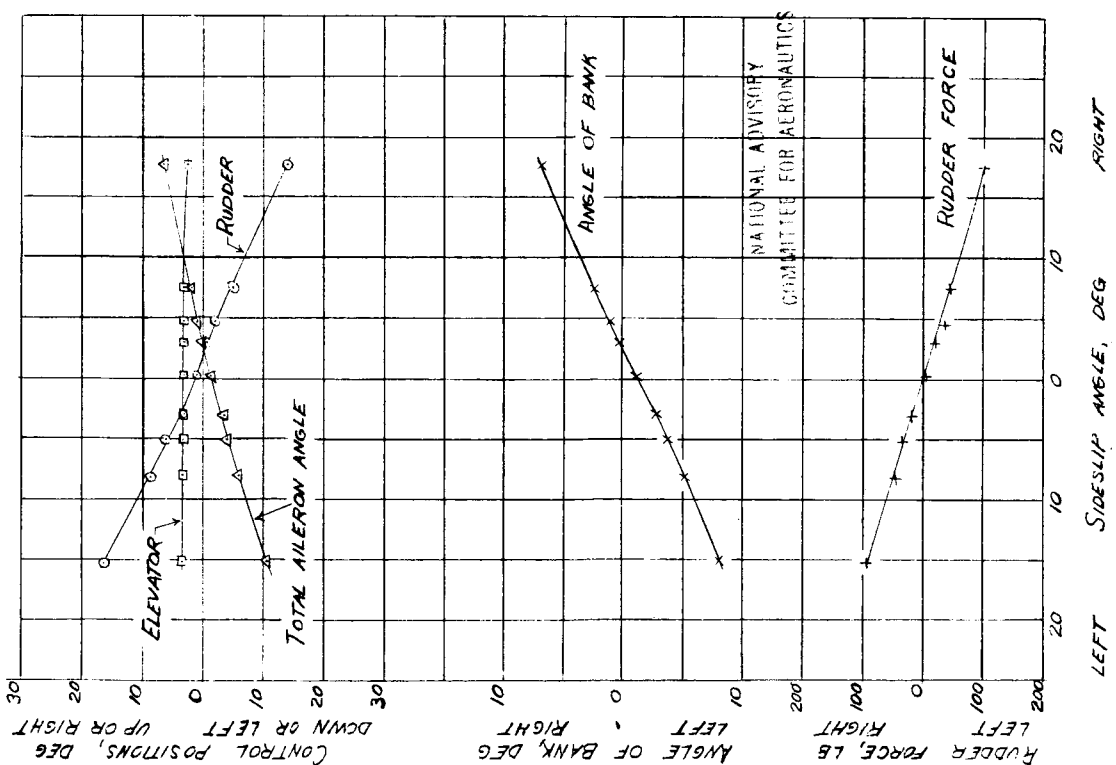
Figure 26. - Steady-sideslip characteristics in the gliding condition at 119 miles per hour (flaps up, power off). Brewster X3BA-1 airplane.

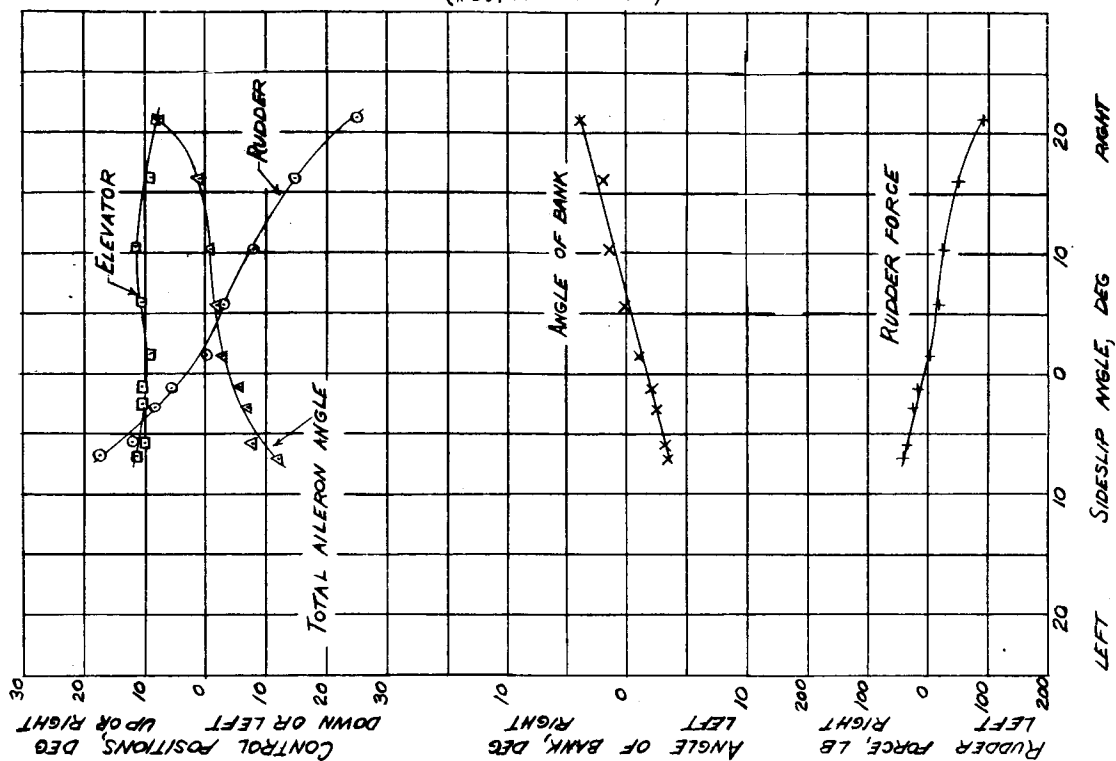
Figure 29. - Steady-sideslip characteristics in the landing condition at 76 miles per hour (flaps down, gear down, power off). Brewster XSB-1 airplane.

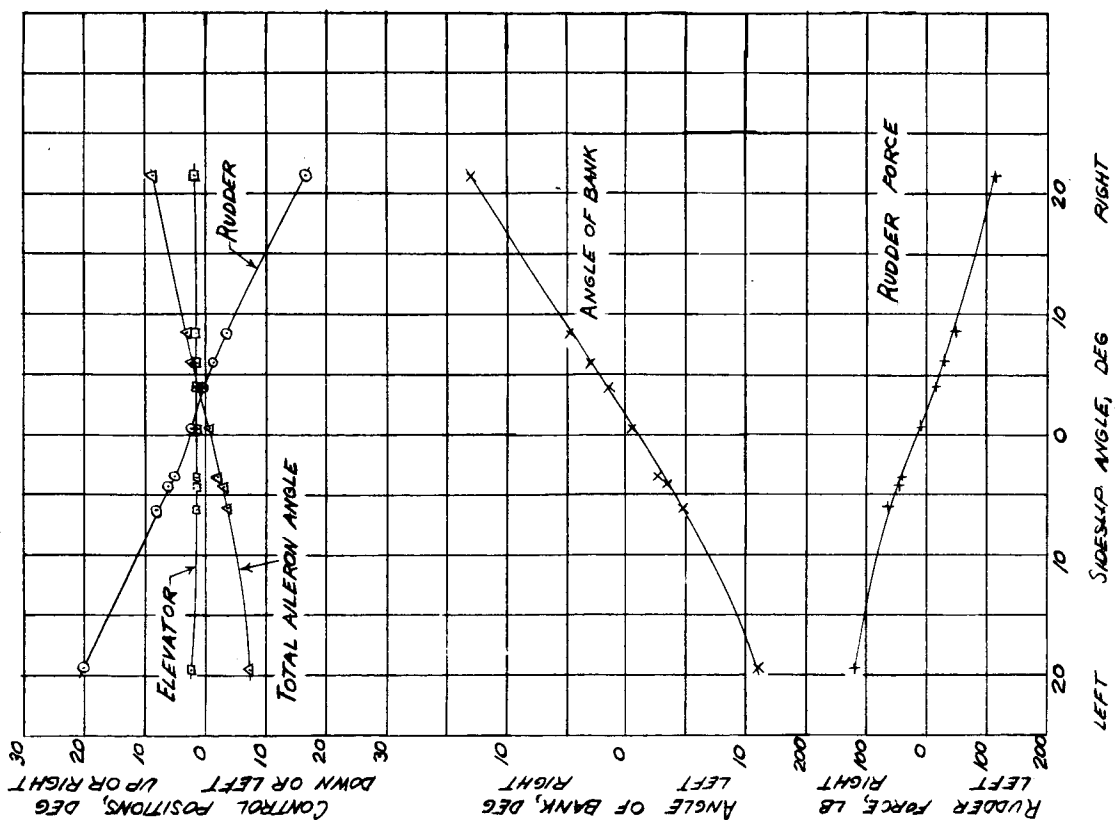
Figure 28. - Steady-sideslip characteristics in the cruising condition at 122 miles per hour (flaps up, gear up, cruising power). Brewster XSB-1 airplane.

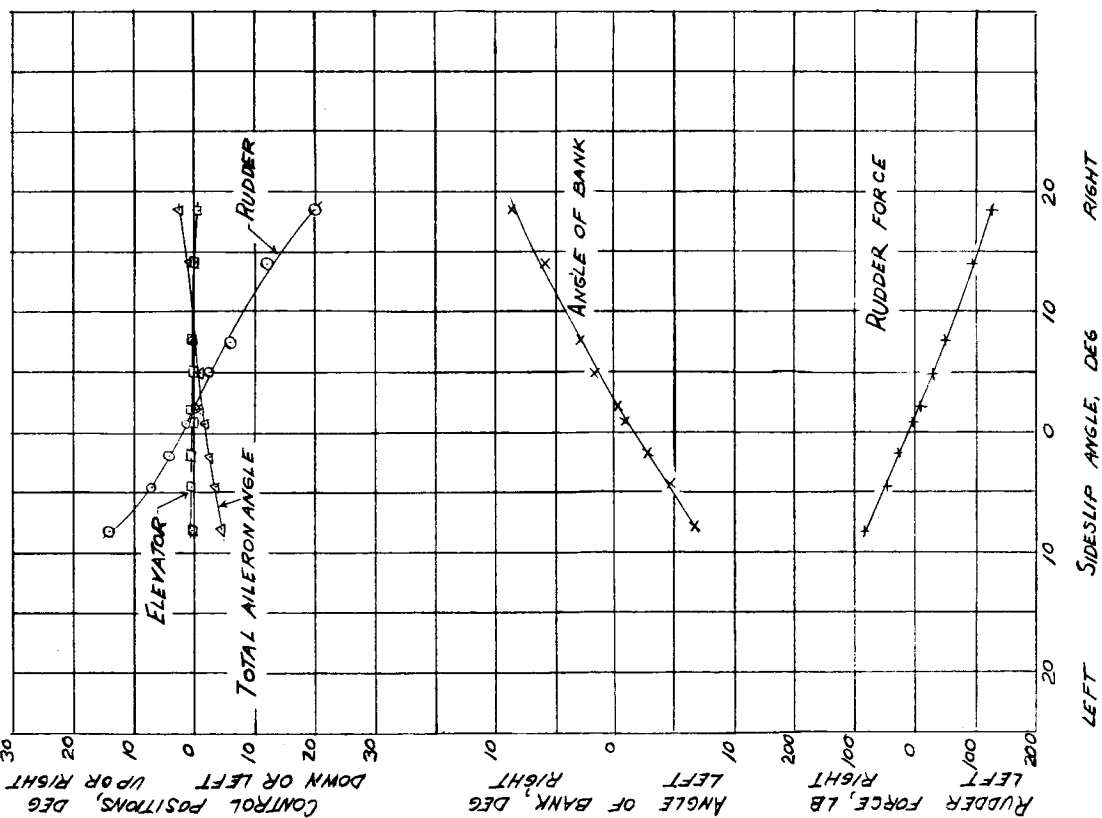
Figure 30. - Steady-sideslip characteristics in the landing condition at 115 miles per hour (flaps down, gear down, power off). Brewster XSBA-1 airplane.

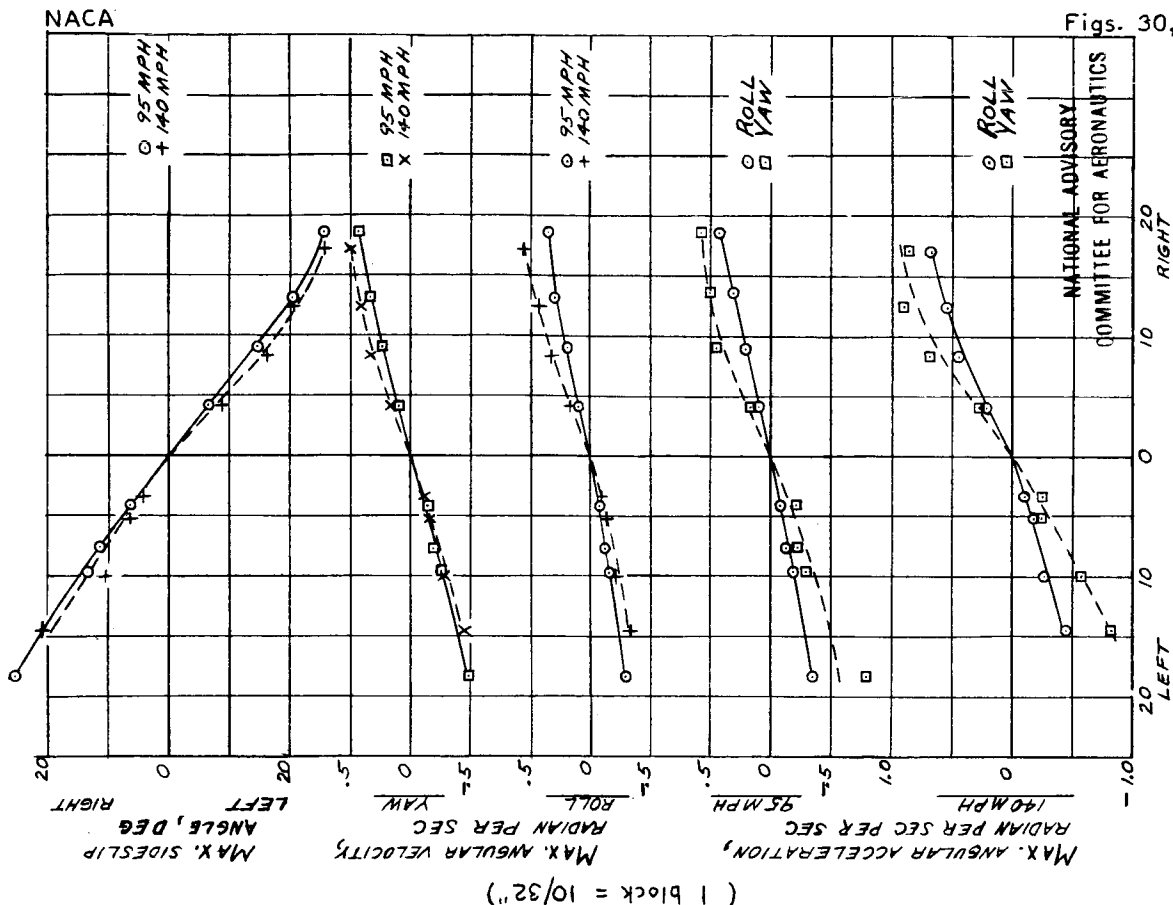
Figure 31. - Variation of maximum values of sideslip angle, angular velocities, and angular accelerations with rudder deflection in abrupt rudder kicks in the cruising condition at 95 and 140 miles per hour (flaps up, gear up, cruising power). Brewster XSBA-1 airplane.

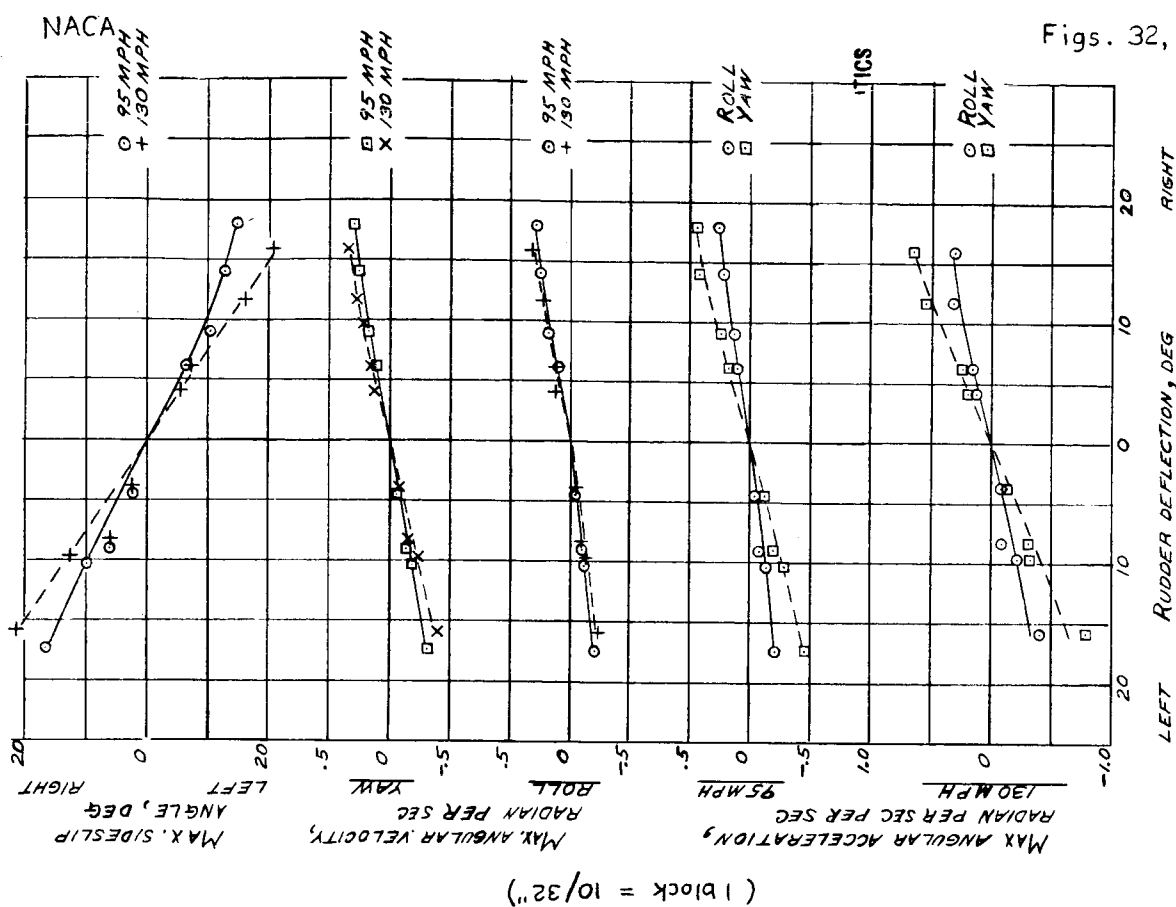
Figure 32. - Variation of maximum values of sideslip angle, angular velocities, and angular accelerations with rudder deflection in abrupt rudder kicks in the gliding condition at 95 and 140 miles per hour (flaps up, gear up, power off). Brewster XSPA-1 airplane.

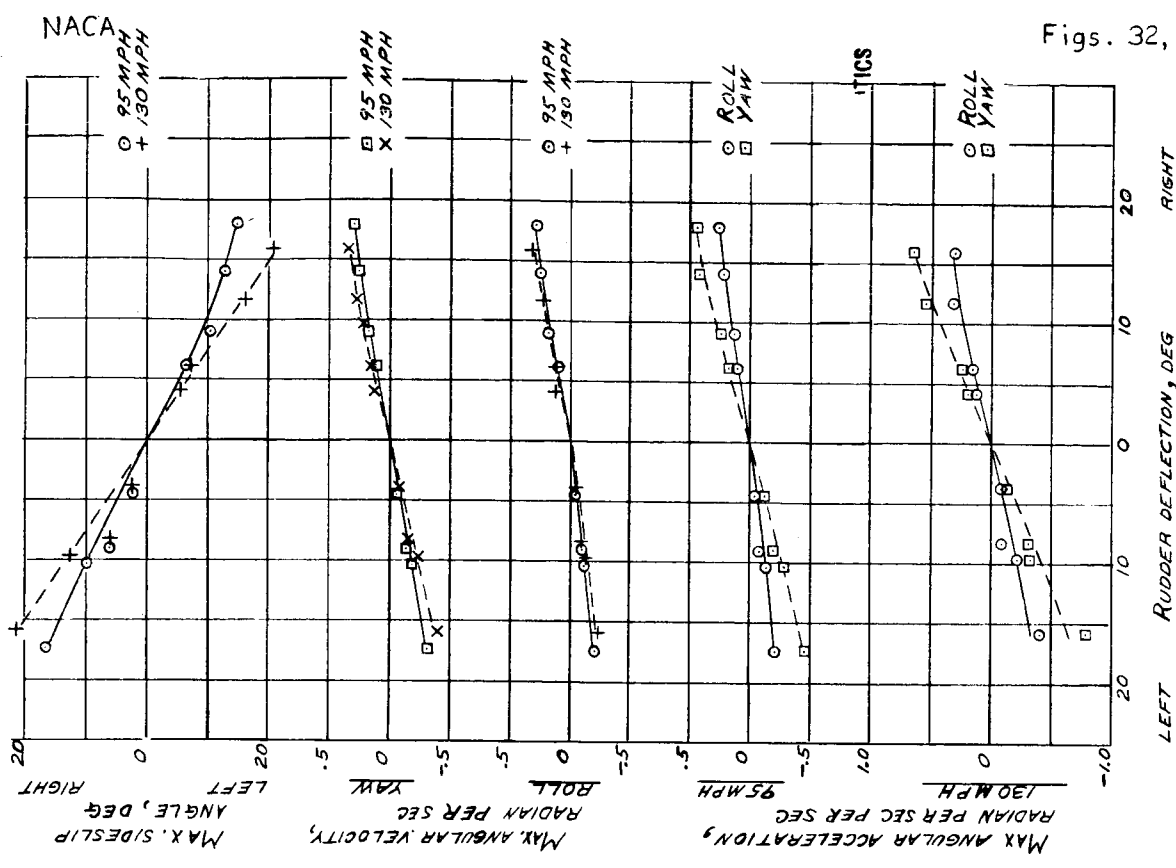
Figure 33. - Variation of maximum values of sideslip angle, angular velocities, and angular accelerations with rudder deflection in abrupt rudder kicks in the landing condition at 95 and 130 miles per hour (flaps down, gear down, power off). Brewster XSPA-1 airplane.

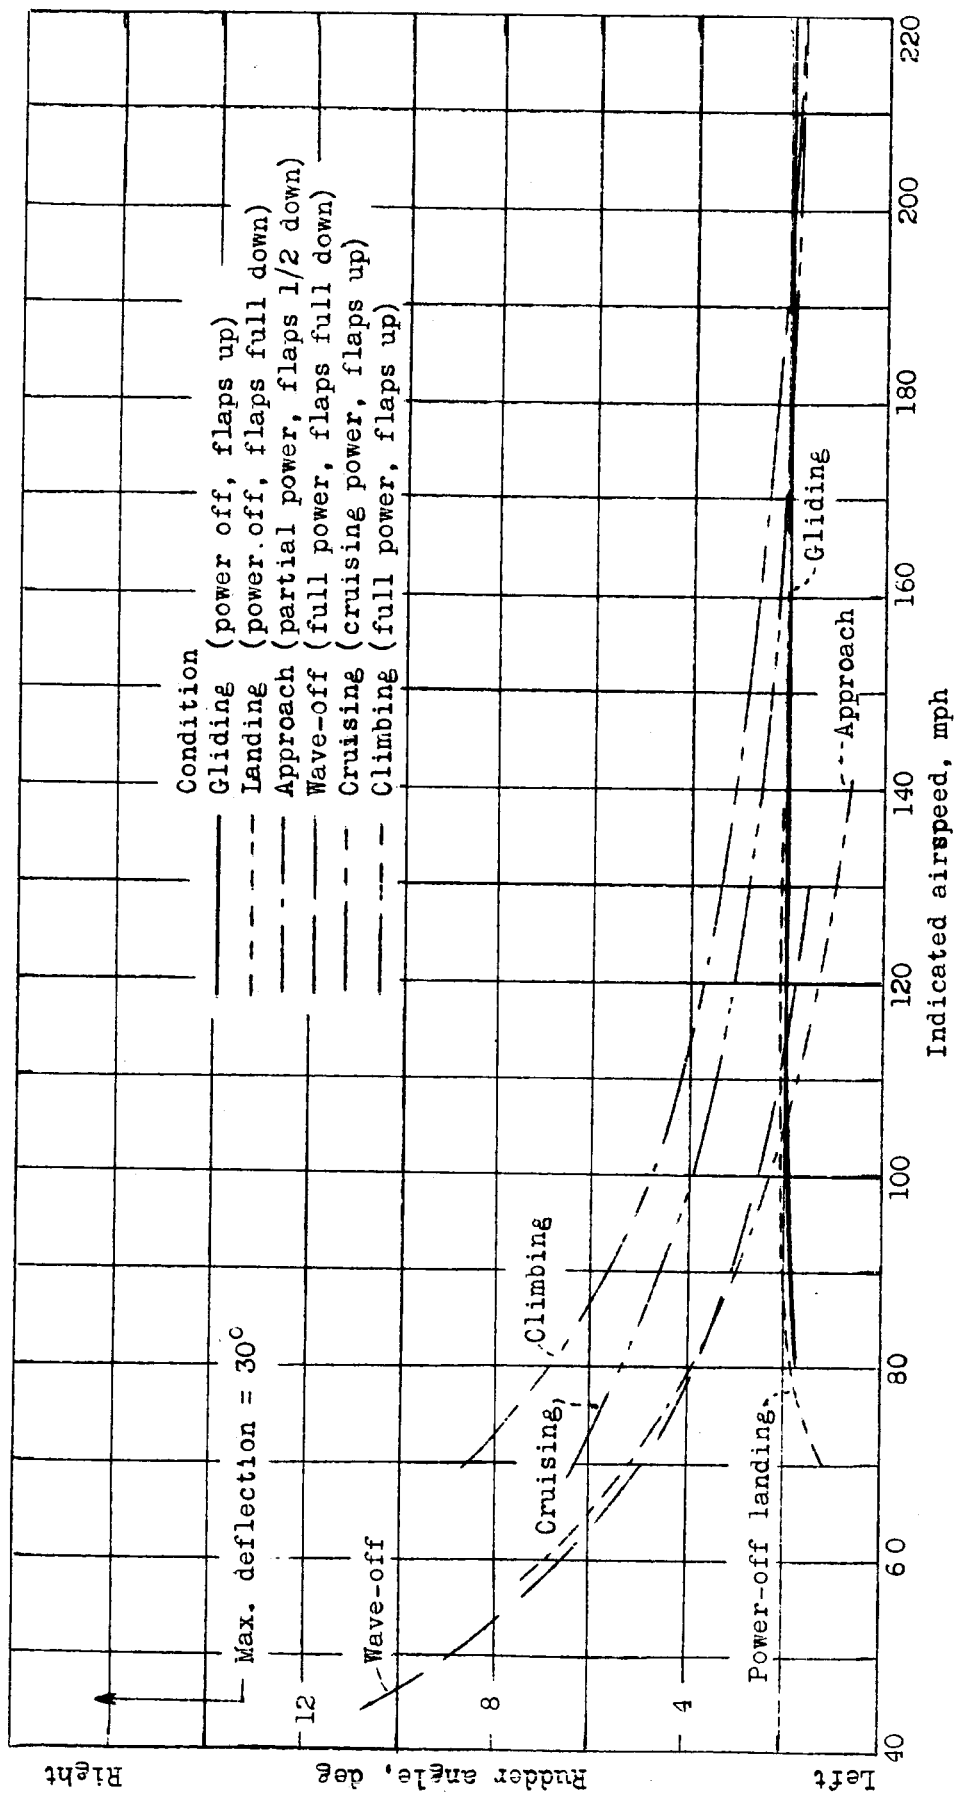
Figure 34.- Variation of rudder angle required for trim with indicated airspeed. Brewster XSBA-1 airplane.

(3) Figure 34 shows that, for each condition tested, the rudder was sufficiently powerful to trim the airplane at all speeds greater than the minimum speed of the airplane.
